# Historical Review of Water Flow and Riparian Vegetation at Walnut Canyon National Monument, Arizona

Technical Report NPS/WRUA/NRTR-92/44

May 1992

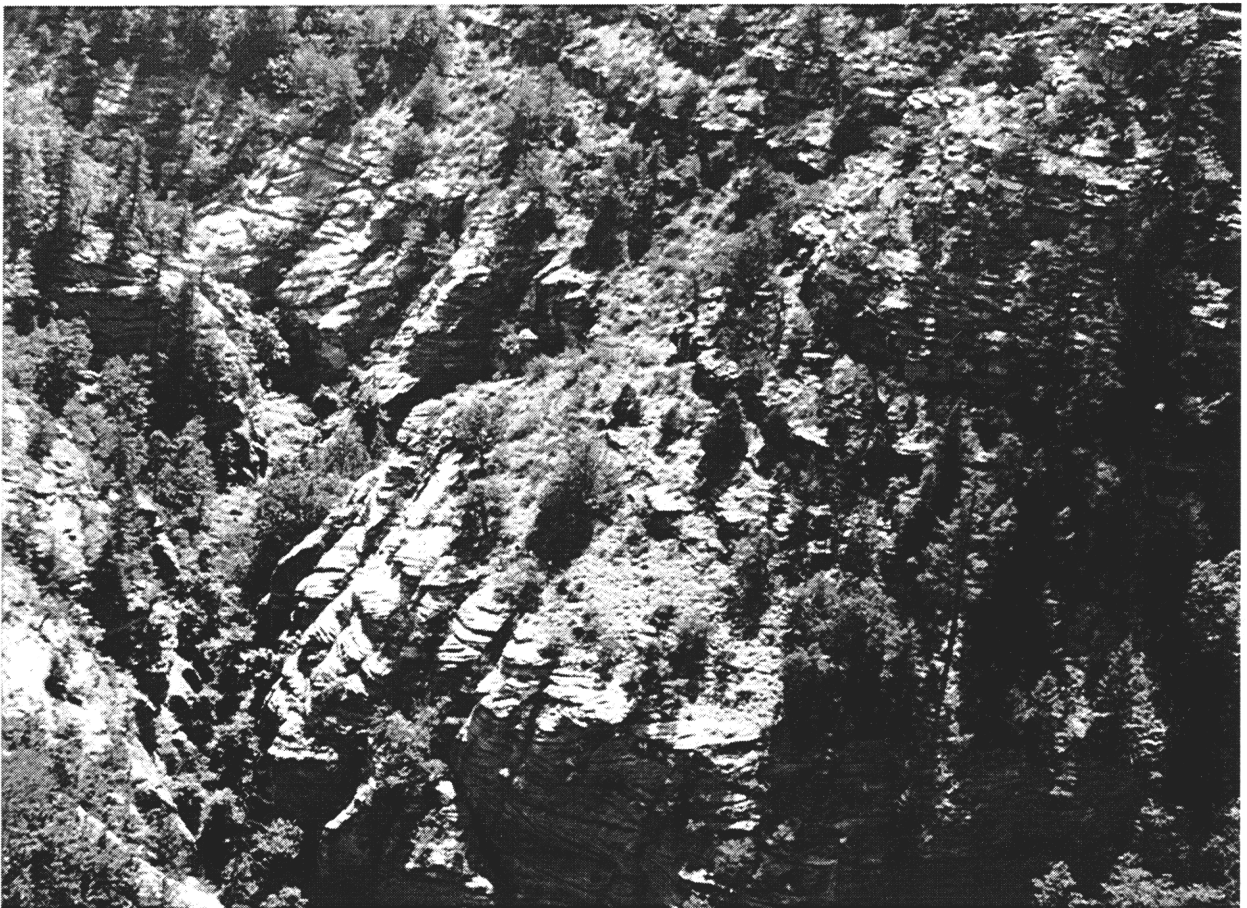
Paul Beaubien, an archaeologist who became the first custodian of Walnut Canyon National Monument, took Figure 4a in 1941. Water can be seen flowing downstream (toward top of photo) with a little "white water" indicating turbulence and flow. By 1966 the stream bottom had developed riparian thickets (N. Ritchie photograph, not shown; WACA Neg. 66-C-5, Classification No. 551.43). The view of the canyon bottom today is choked by vegetation (Fig. 4b). However, the vegetation on the east-facing slope to the right and center of the photograph has changed little. The same tree and shrub individuals can easily be matched from 1941 to 1985.

Figure 4a. "View into Walnut Canyon showing running water in canyon bottom and contact between Kaibaba Limestone and Coconino Sandstone, several under-ledge ruins visible," Paul Beaubien photographer, May 1941, Walnut Canyon National Monument, Arizona. WACA Neg. 6409.

Figure 4b. Looking downstream and south from visitor center (Island to left), August 1985, Walnut Canyon National Monument, Arizona.

4. Vegetation on east- and south-facing slopes has changed little since the turn of the century. Plants can easily be matched when comparing recent photos with those from 1941 (Fig. 4), and 1974 (Figs. 6 and 10).

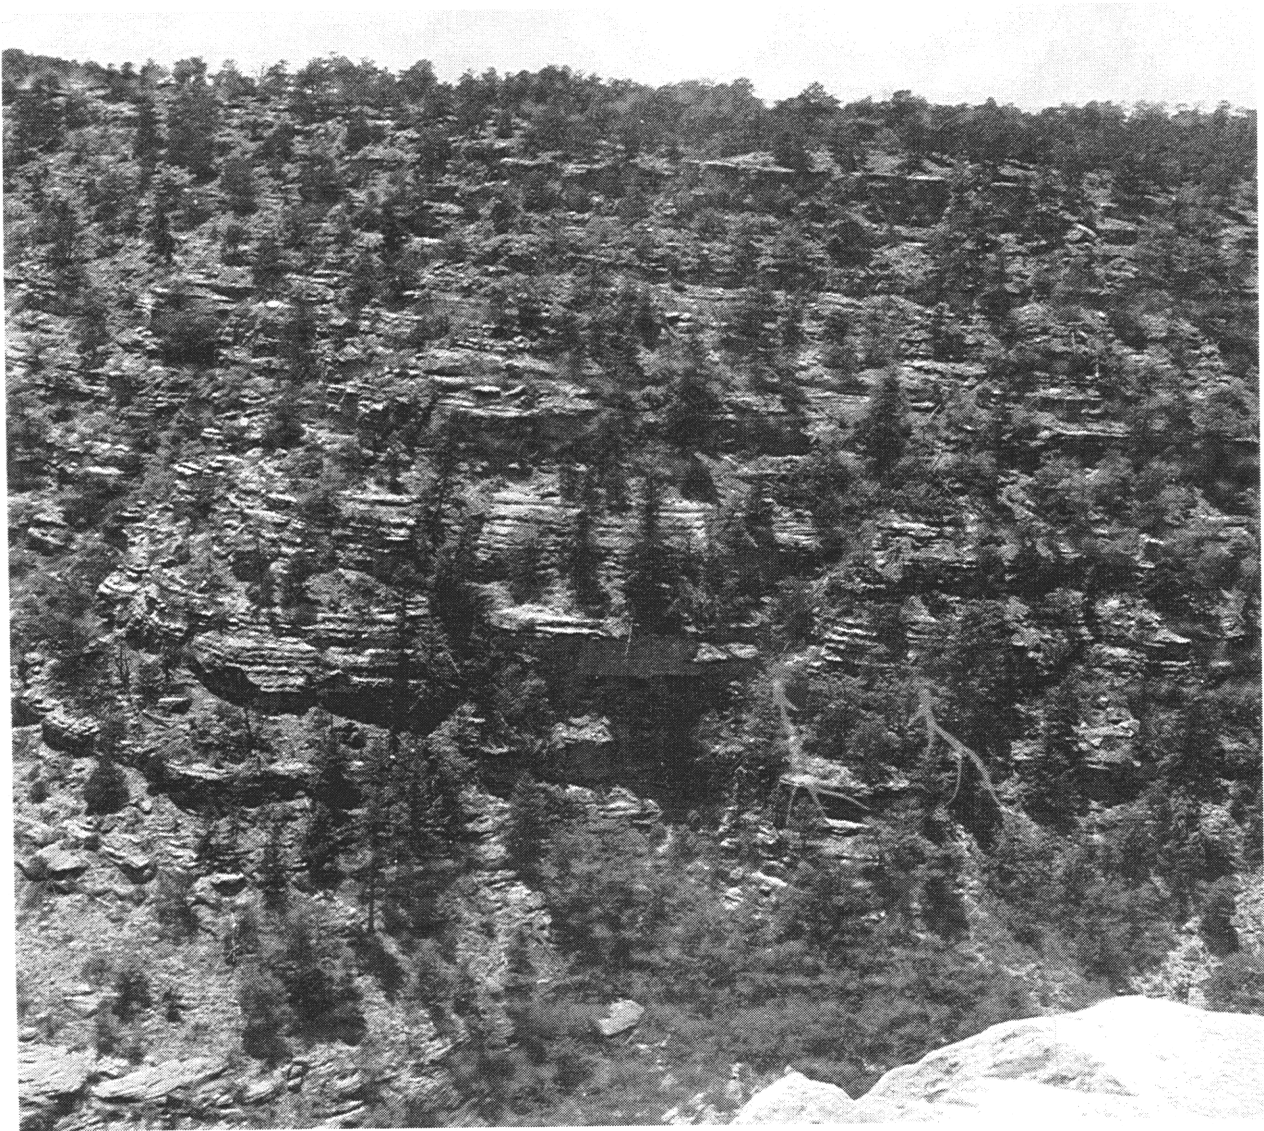
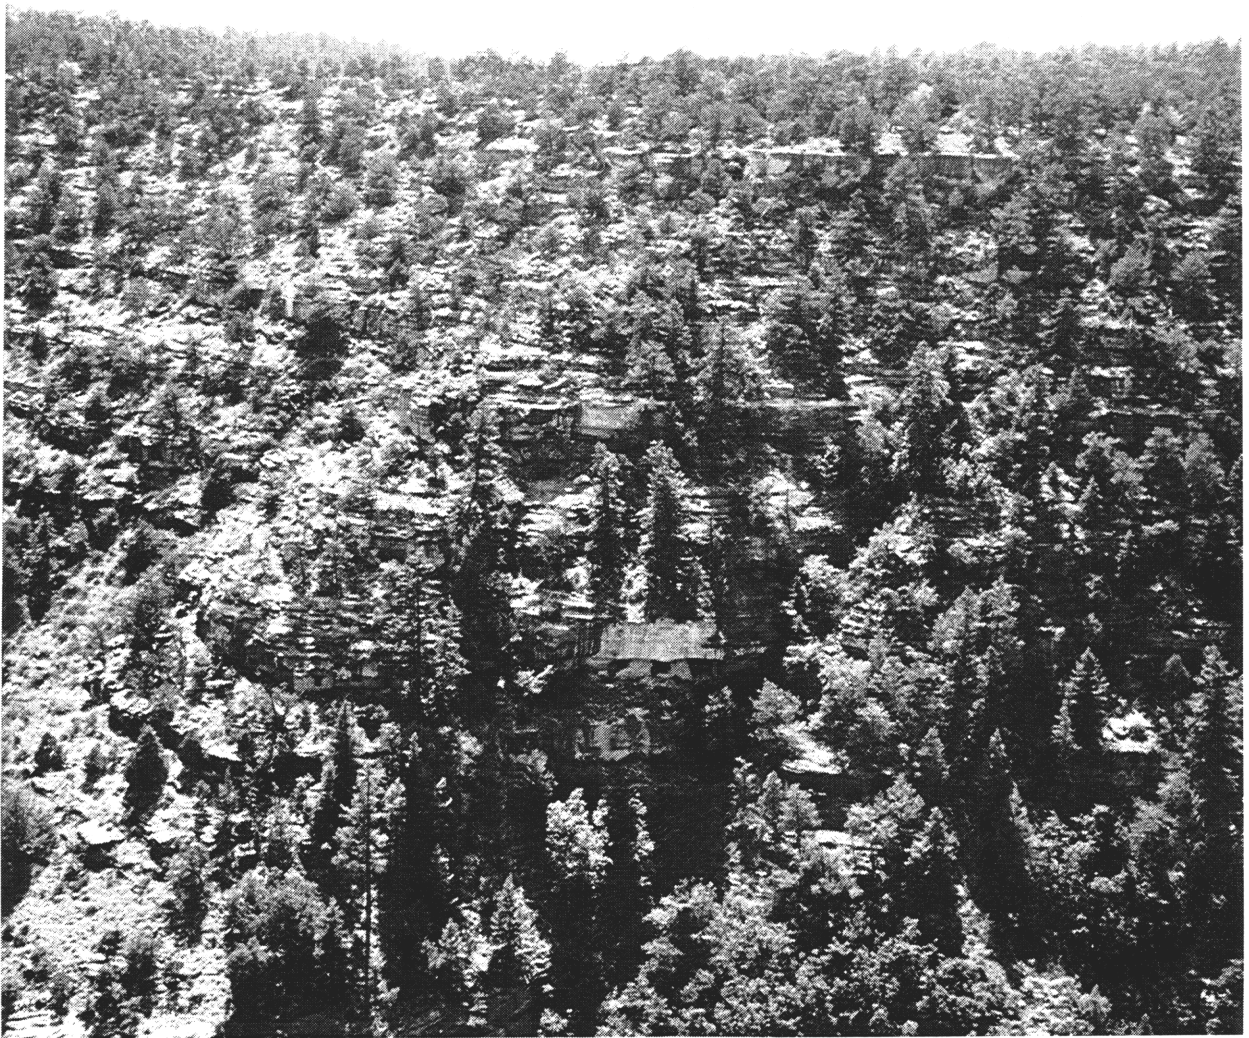
Only 11 years have elapsed since the original photograph (Fig. 5a) was taken in 1974, and little vegetation change has occurred. Tree and shrub individuals can easily be matched between the photos.

Figure 5a. View of north-facing slope of canyon above riparian zone, Walnut Canyon National Monument, Arizona. No locality information, 1974, Paul Switzer Collection, 1974, NAU 426-605-6, Special Collections Library, Northern Arizona University.

Figure 5b. View across canyon to south rim opposite visitor center (Island to left), August 1985, Walnut Canyon National Monument, Arizona.

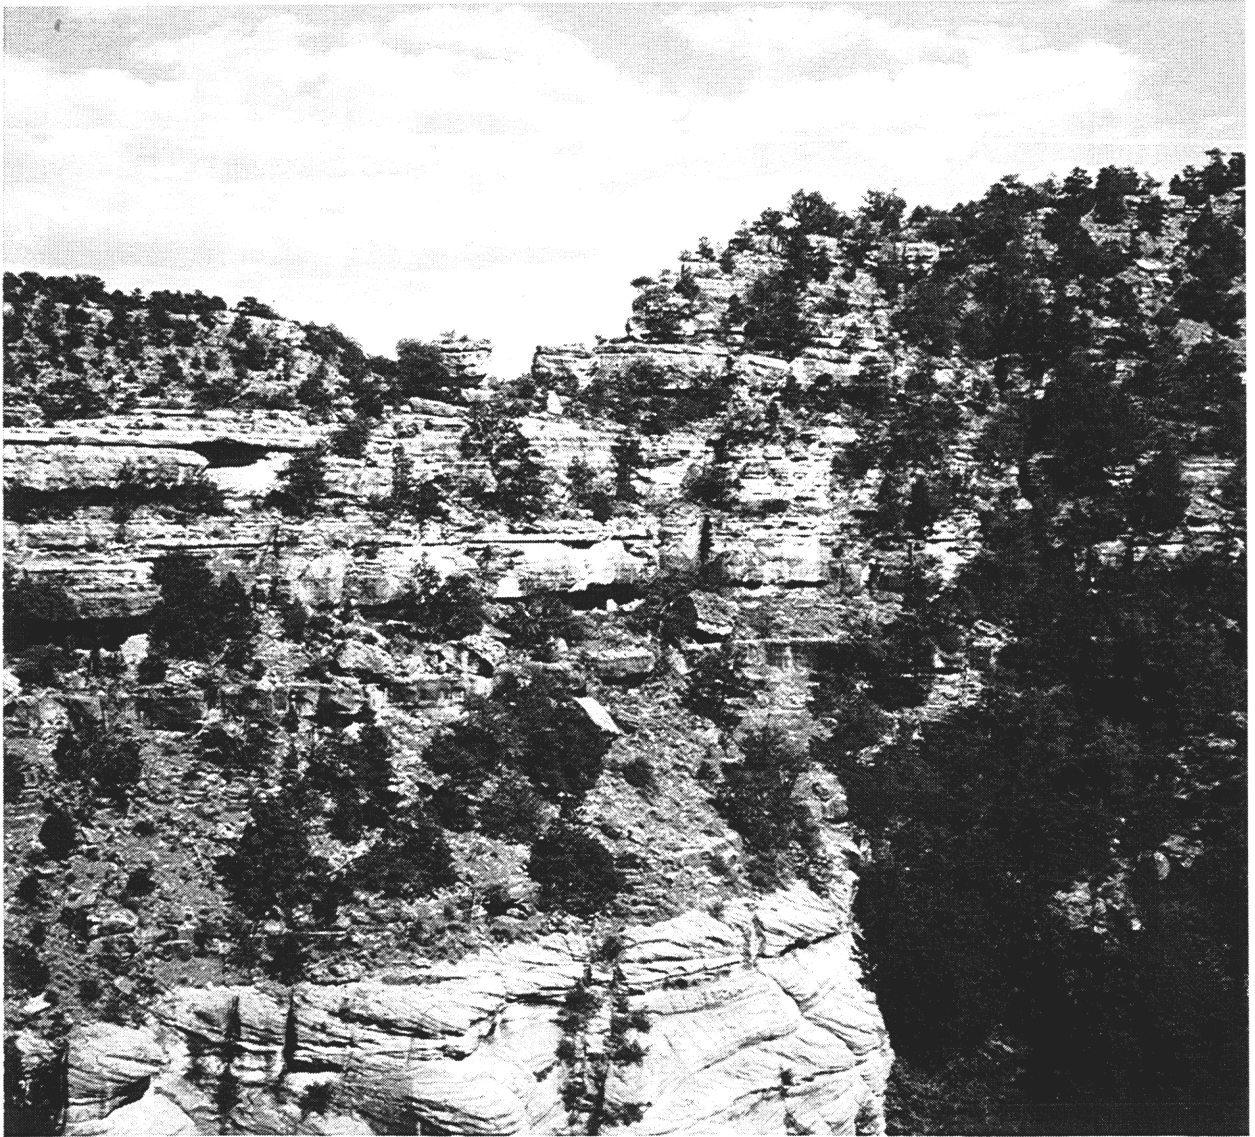
Eleven years have elapsed since the original photo (Fig. 6a) was taken in 1974. Little change is visible between Figures 6a and 6b, and shrubs can easily be matched. The riparian vegetation at bottom right is similar.

Figure 6a. View of southwest-facing slope opposite Island, 1974, Walnut Canyon National Monument, Arizona. No locality information, Paul Switzer Collection, 1974, NAU 426-606-11, Special Collections Library, Northern Arizona University.

Figure 6b. View east from Island across canyon to south rim, August 1985, Walnut Canyon National Monument, Arizona.

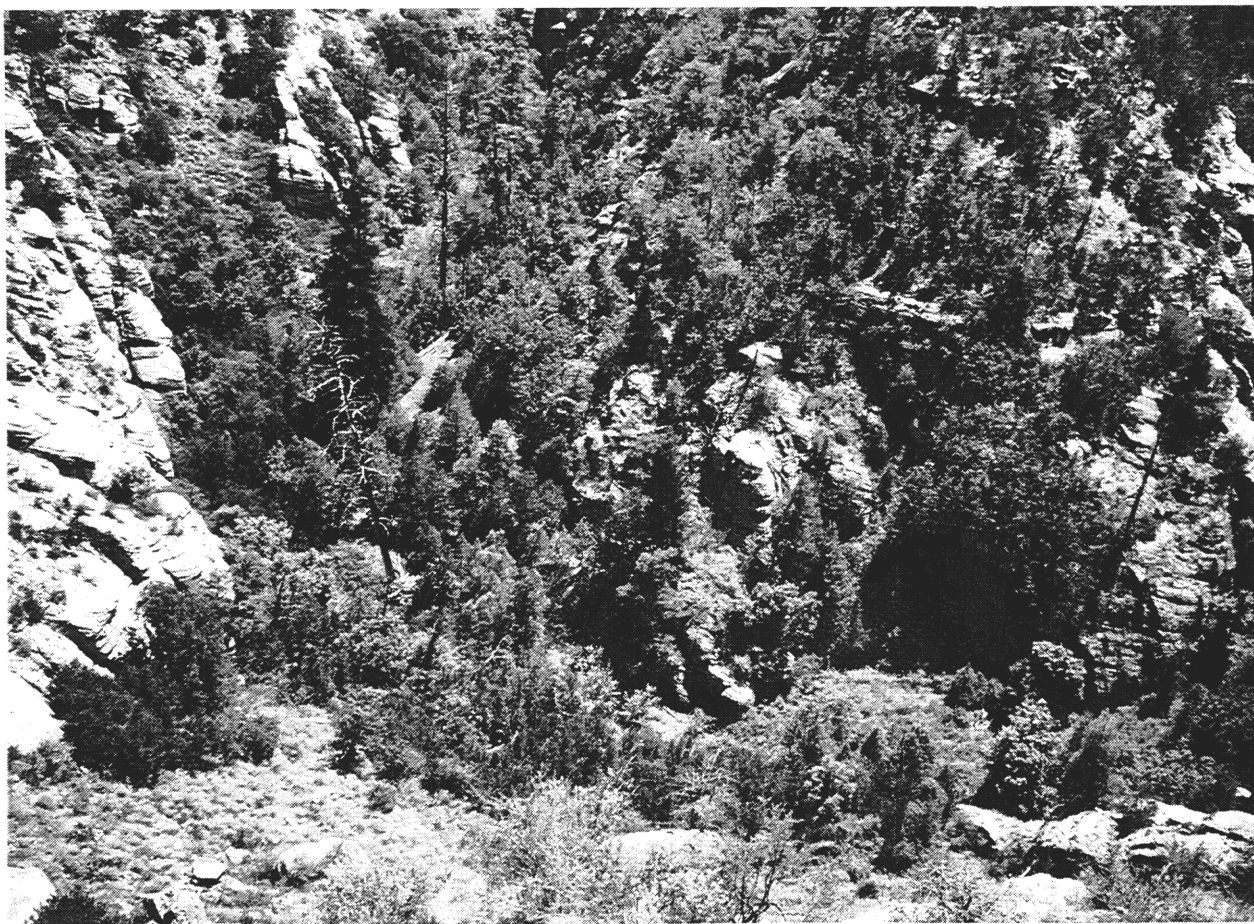
This photo pair is somewhat difficult to compare because the 1964 photo (Fig. 7a) was printed backwards. Use boulders in Figure 7a (far right) as orientation; they are located at far left in Figure 7b. A few standing dead snags are visible in both photos; however, the riparian vegetation has grown extensively in the intervening 21 years. The canyon bottom appears more lush in Figure 7b with the canopy cover filling the stream channel from bank to bank.

Figure 7a. "Tree fall in canyon from #2 to east, N. Ritchie photographer, April 25, 1964," Walnut Canyon National Monument, Arizona. WACA Neg. 64-38.

Figure 7b. View east (down-canyon) from trail leading to Island saddle, August 1985, Walnut Canyon National Monument. Note: Figure 7a is printed backwards (location is as in Figure 7b), and #2 does not refer to the Second Fort.

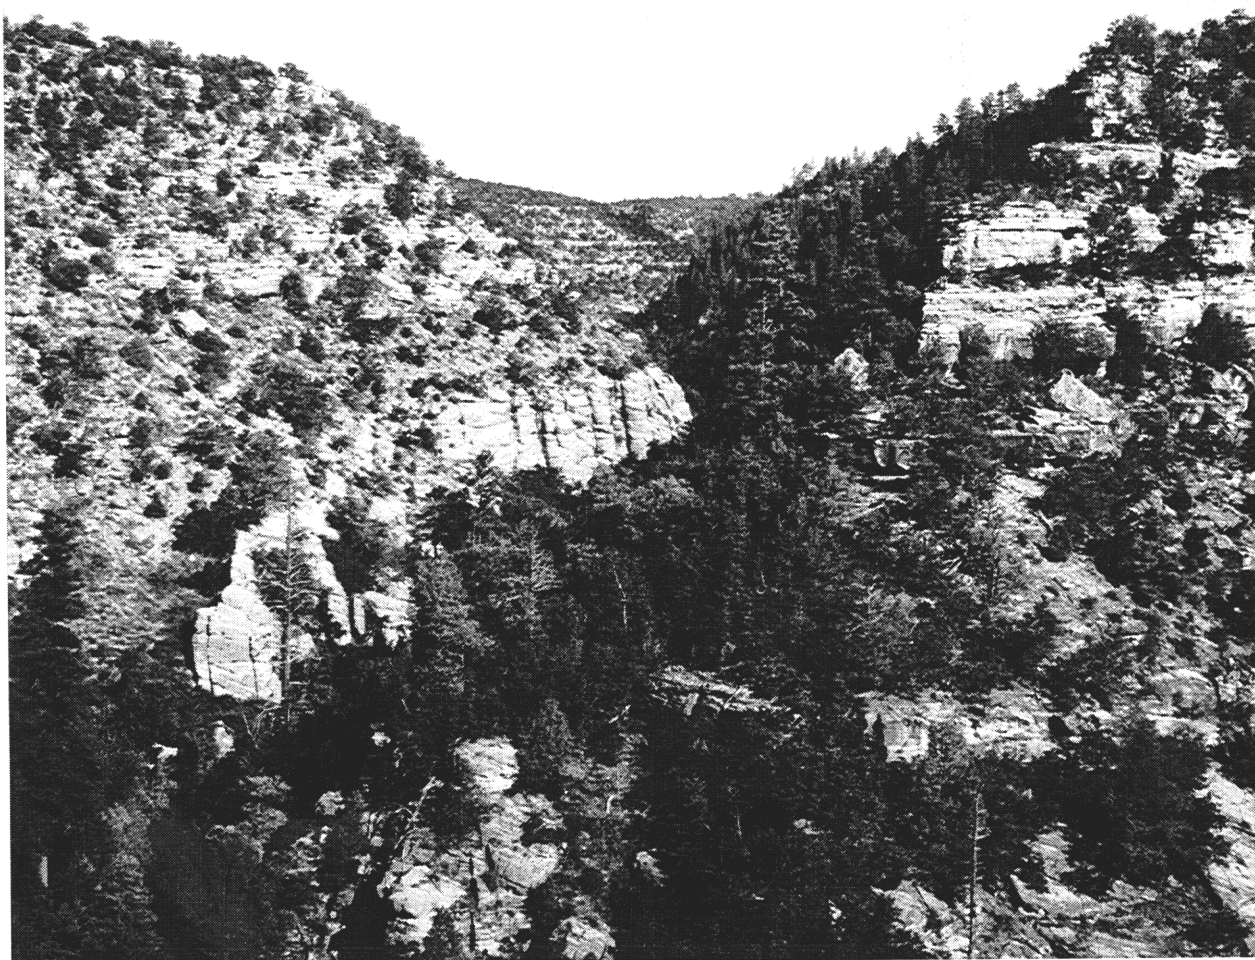
Figure 8 is similar to Figure 7, with the view to the east and up-canyon. Eleven years have elapsed since the original photo (Fig. 8a) was taken in 1974. Two obvious standing dead snags are visible in both photos. Vegetation on the canyon slopes has not changed appreciably.

Figure 8a. Looking up-canyon, 1974, Walnut Canyon National Monument, Arizona. No locality information, Paul Switzer Collection, 1974, NAU 426-606-12, Special Collections Library, Northern Arizona University.

Figure 8b. Looking east, up-canyon from saddle of Island, August 1985, Walnut Canyon National Monument, Arizona.

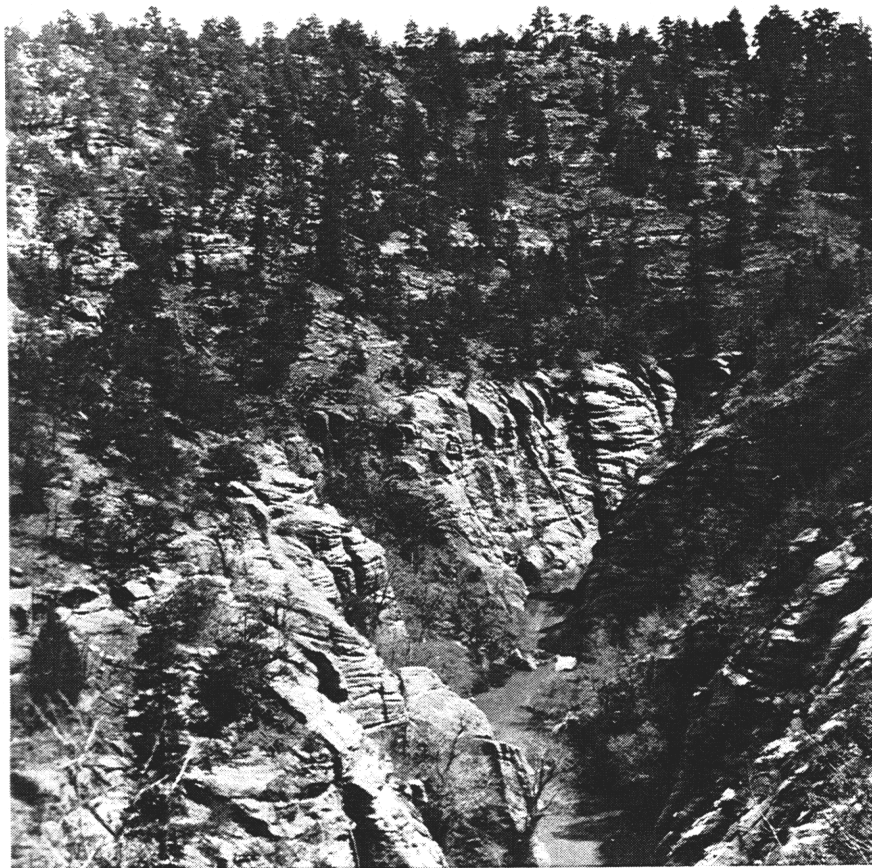
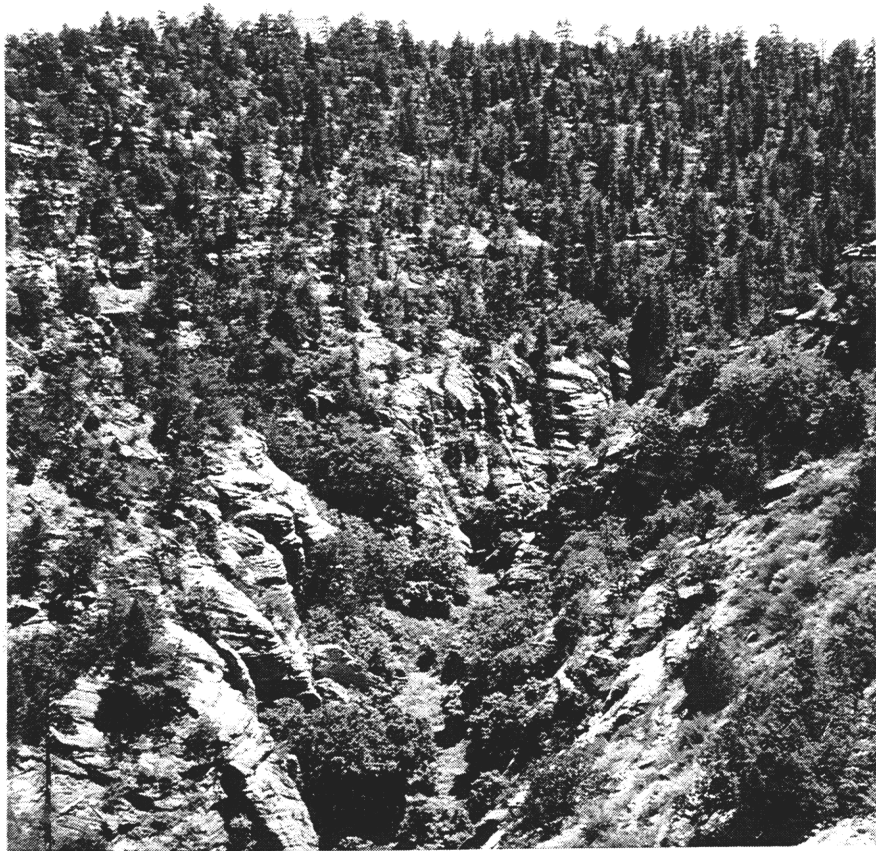
Figure 9a shows water apparently pooled in Walnut Canyon in 1941. Presumably, the water had overflowed the Upper and Lower Lake Mary dams. In 1941, Flagstaff received 63.55 cm (25.02 in.) of precipitation. The previous year 53.89 cm (21.22 in.) were recorded (Green and Sellers 1964). Both years exceeded the 1899-1951 mean precipitation of 51.49 cm (20.27 in.). Consequently, Walnut Creek should have had a good opportunity to receive overflow water from the reservoirs. No flow over the rocks in the center of the channel is apparent. Consequently, the water in Figure 9a appears to be pooled. Possibly, the Santa Fe Dam had pooled the flow and created a reservoir backed up to and upstream of the Island. The recent photo (Fig. 9b) exhibits the amount of vegetation that has grown in the intervening 44 years. Some open area is, however, still visible. One may walk this section of the canyon bottom without encountering the jungle-like growth found just upstream.

Figure 9a. "Walnut Canyon with water in stream," Paul Beaubien photographer, 1941, Walnut Canyon National Monument, Arizona. WACA Neg. 6595, Classification No. 551.57.

Figure 9b. Looking south on eastern side of Island from trail leading to Island saddle, August 1985, Walnut Canyon National Monument, Arizona.

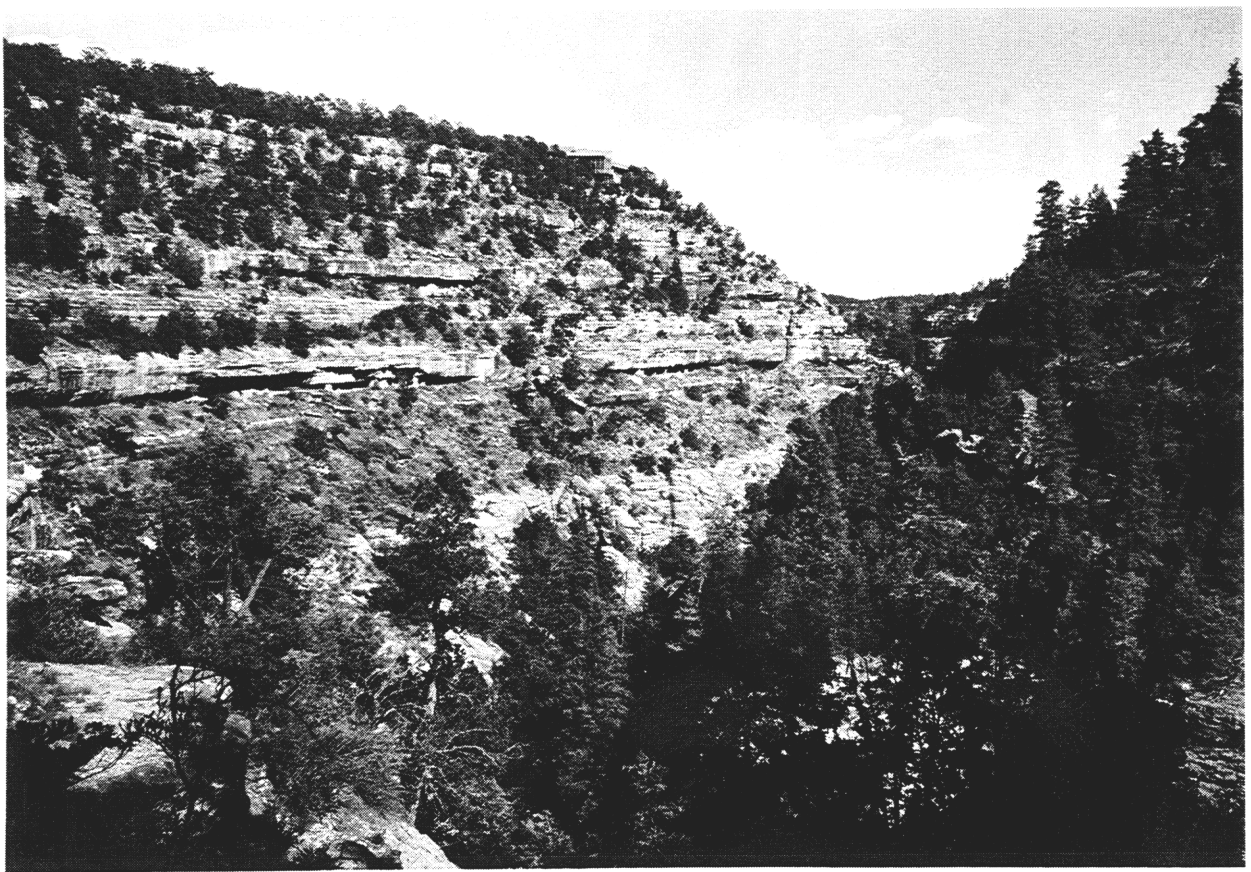
Figure 12 shows a view of the ridge line on the Island from the abandoned trail below the old ranger cabin to the west of the visitor center. A circa 1900 postcard (not shown) of Walnut Canyon indicates some water present in the drainage (George Hochderffer Collection, NAPHS 321145, Special Collections Library, Northern Arizona University). Seventy-nine years have elapsed between Figure 12a and Figure 12b. Vegetation change is readily apparent for the northwest-facing slope at the right of each photo. The 1906 photo shows an almost denuded northwest-facing slope with much of the rocky area visible. The lack of vegetative cover on this slope may have resulted from wildfire. The recent photo shows the slope covered with evergreen trees and other small trees and shrubs. Trees and shrubs on the south-facing slope (left) can be matched. The canyon bottom is choked with riparian vegetation.

Figure 12a. "Canyon and ruins, looking southeast [downstream] from visitor center near saddle of Island Trail," Henry G. Peabody photographer, April 1906, Walnut Canyon National Monument, Arizona. WACA Neg. 12,324, Classification No. 571.84.

Figure 12b. Looking east at Island from abandoned trail below old ranger cabin, August 1985, Walnut Canyon National Monument, Arizona.

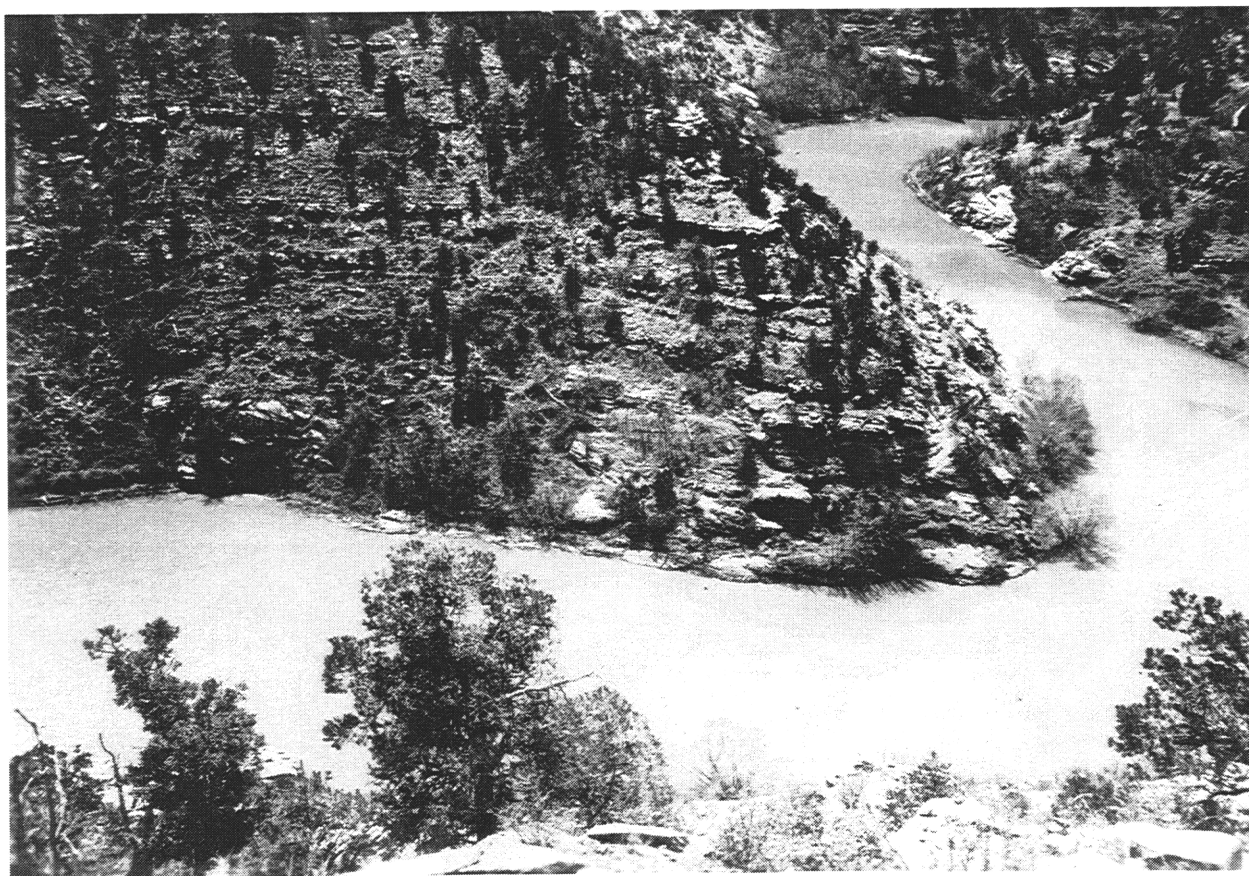
Figure 13 shows a meander in Walnut Canyon about 0.4 km (0.25 mi) above Santa Fe Dam in 1939. The "lake" or reservoir held water that presumably overflowed the Lower Lake Mary Dam. (The dam for Upper Lake Mary had not yet been built). The Flagstaff area received 52.27 cm (20.58 in.) of precipitation in 1938 and less than 10.16 cm (4 in.) for the first 4 months of 1939 (Green and Sellers 1964), an amount typical for the 1899-1951 period. The deciduous trees—Arizona walnut (*Juglans major*), Gambel oak (*Quercus gambelii*) and box elder (*Acer negundo*)—at the shoreline have not leafed out in the 1939 photo, but can be seen in the same locations in the recent photo. Today, the dry reservoir bed or canyon bottom is filled with an almost pure stand of common sunflower (*Helianthus annuus*), a plant that thrives in disturbed, deep, sandy soils. Little vegetation change is apparent on the canyon slopes.

Figure 13a. "Walnut Canyon, lake about 1/4 mile above Santa Fe Dam, near Walnut Canyon National Monument," Paul Beaubien photographer, April 16, 1939. WACA Neg. 2608, Classification No. 551.48.

Figure 13b. View upstream and south from south-facing canyon slope approximately 0.4 km (0.25 mi) above Santa Fe Dam, August 1985, Walnut Canyon National Monument, Arizona.
